EARL STONHAM VILLAGE HALL

FIRE RISK ASSESSMENT AND FIRE SAFETY ACTION PLAN

Fire Risk Assessment

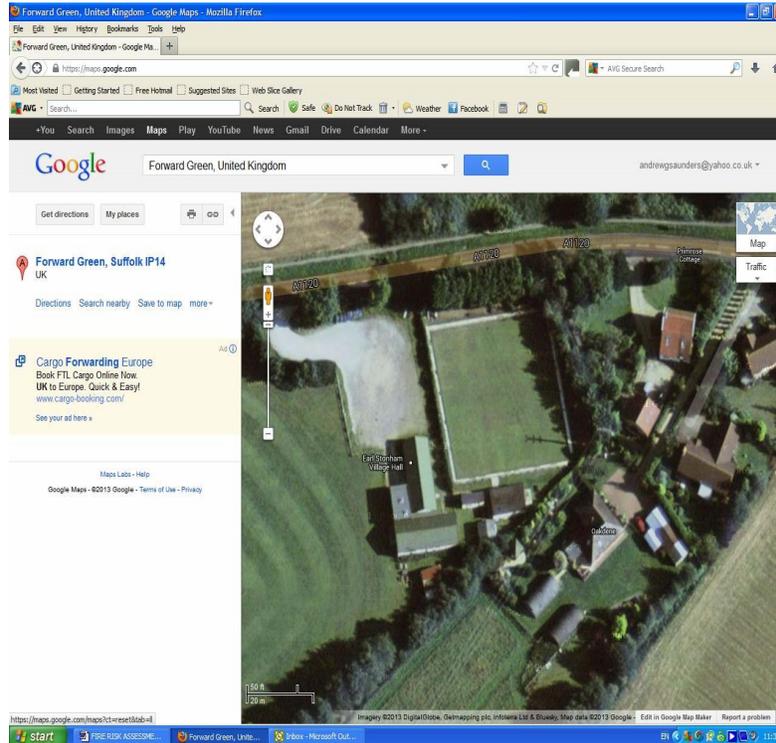
Earl Stonham Village Hall – aerial view of the site

The hall complex is a single storey building, comprising two older sections, constructed in the 1940s, linked by a more modern extension for the entrance area, with a disabled toilet. An aerial view of the site and a layout plan are attached (Appendix 1). The main hall is approximately 60' x 20', and the second unit comprising the club room, kitchen and toilets is of similar size.

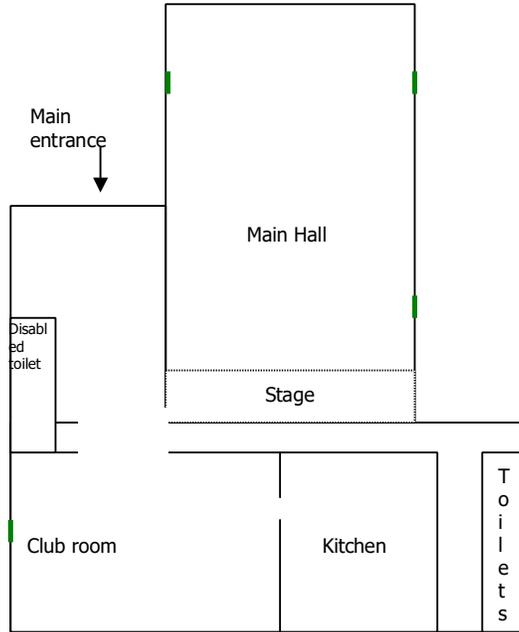
Earl Stonham Village Hall – Internal Layout (not to scale)

█ denotes fire exit

It should be noted, however, that in the main hall the fire exits are built on a raised plinth 6" above floor level which would make egress difficult for those with impaired mobility or a visual impairment. In addition, external ramps are required for 3 of the exits to facilitate escape from the building. It is planned to locate portable ramps adjacent to each fire exit in the main hall, although these could be a trip hazard in their own right. In the meantime, all hirers of the main hall will be alerted to the need to ensure arrangements are in place to support those with a mobility or visual impairment to exit the main hall via the fire exits and this will be added to user guidelines.
